AVALANCHE CADASTRE FOR SLOVENE ALPS AND ITS MEANING FOR AVALANCHE PREVENTION

ICA workshop, Bohinj, 30. 3. 2006

M i h a P A V Š E K M. Sc.
Geographical Institute SRC SASA
Novi trg 2, 1000 Ljubljana, Slovenia
Tel.: +386 1 47 06 361
Fax: +386 1 42 57 793
E-mail: miha.pavsek@zrc-sazu.si
Home page: <http://www.zrc-sazu.si/gi/>

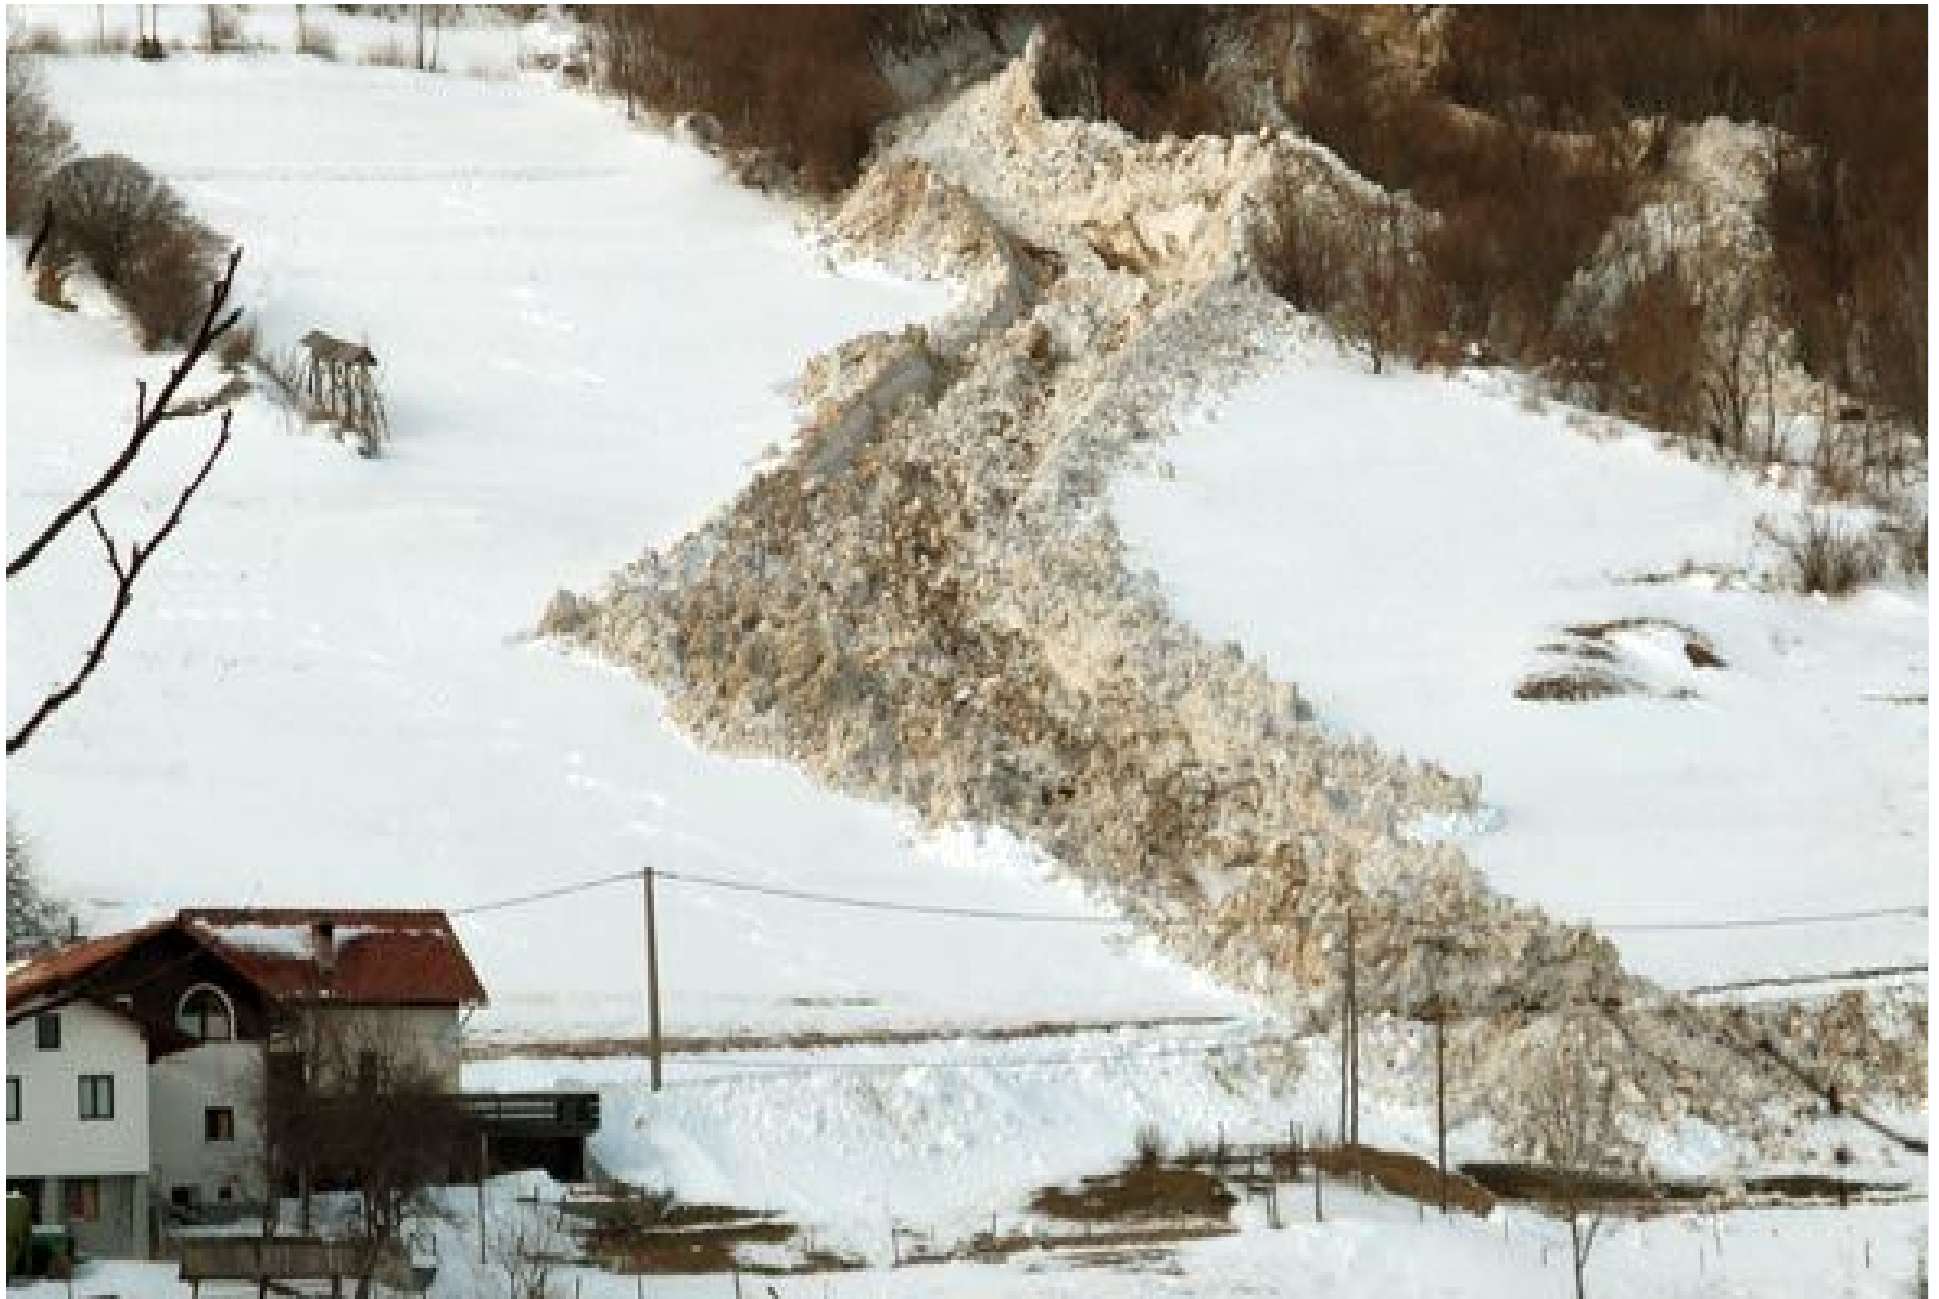
The ruins of houses in Upper Borjana and the village Stržišče above Bača valley

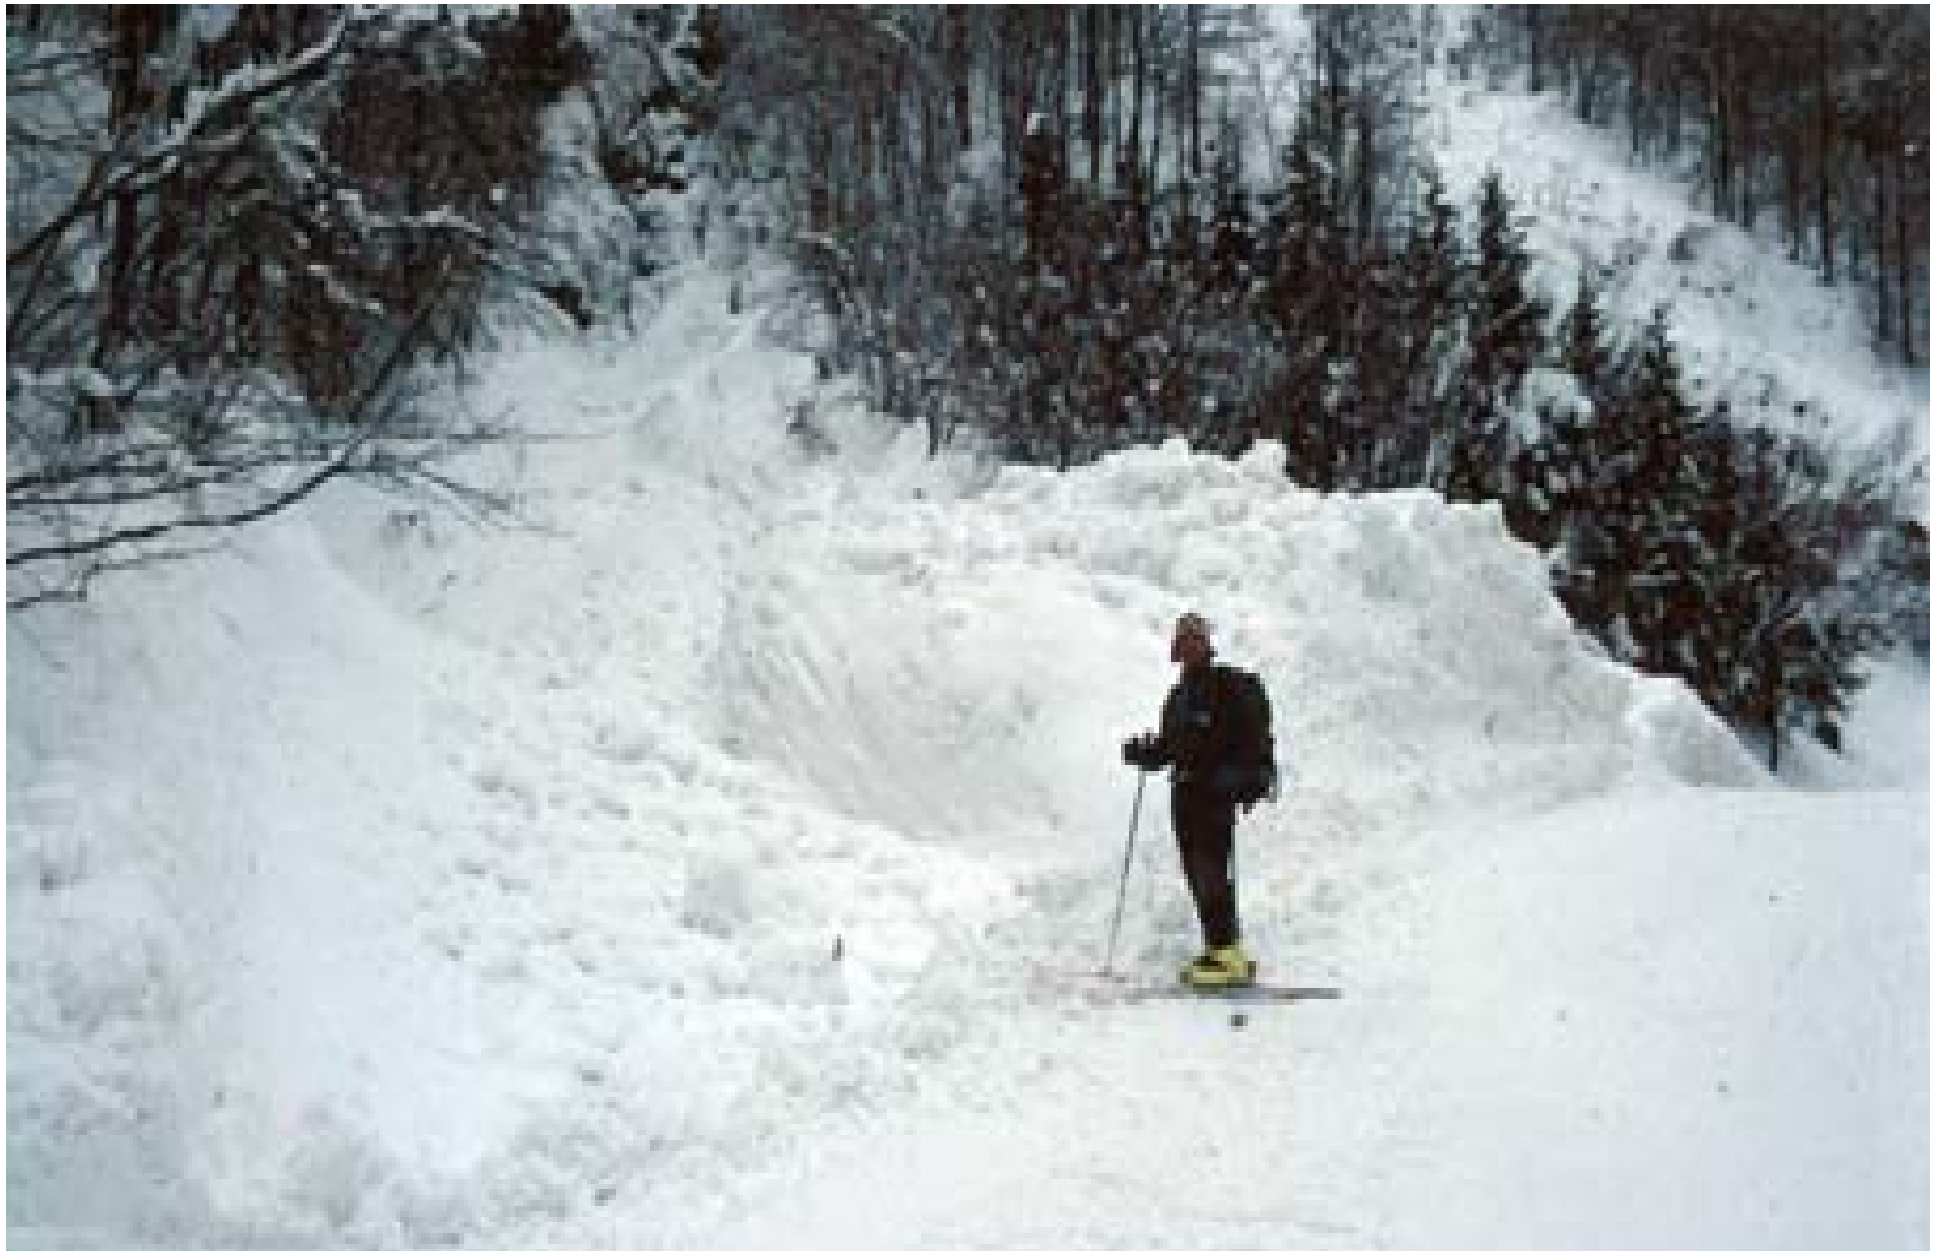
Avalanche prone objects: local and main roads, power cables, ski resorts...

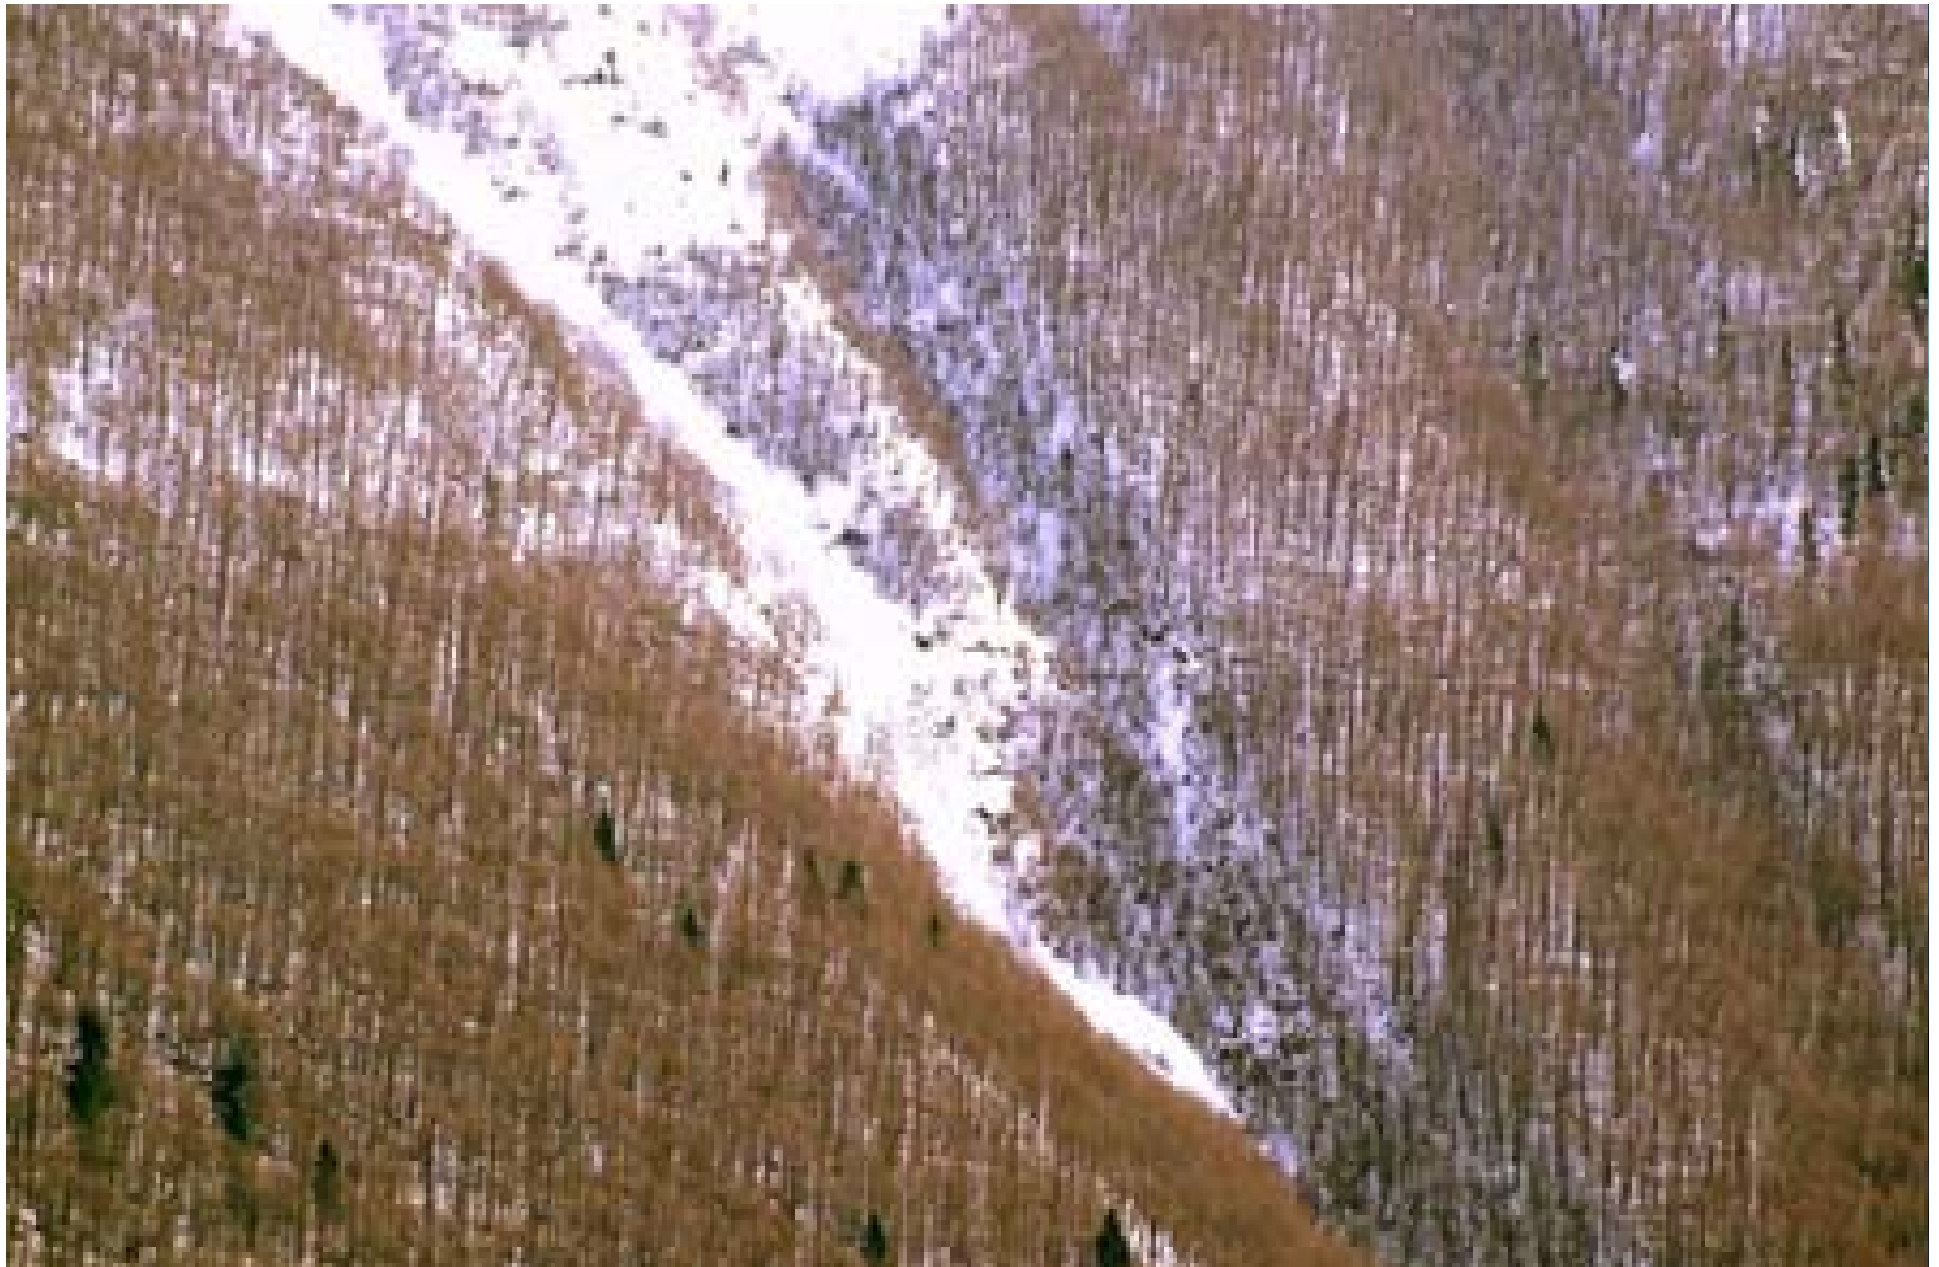
Forests - most endangered and at the same time most important for prevention (protection against snow erosion processes)

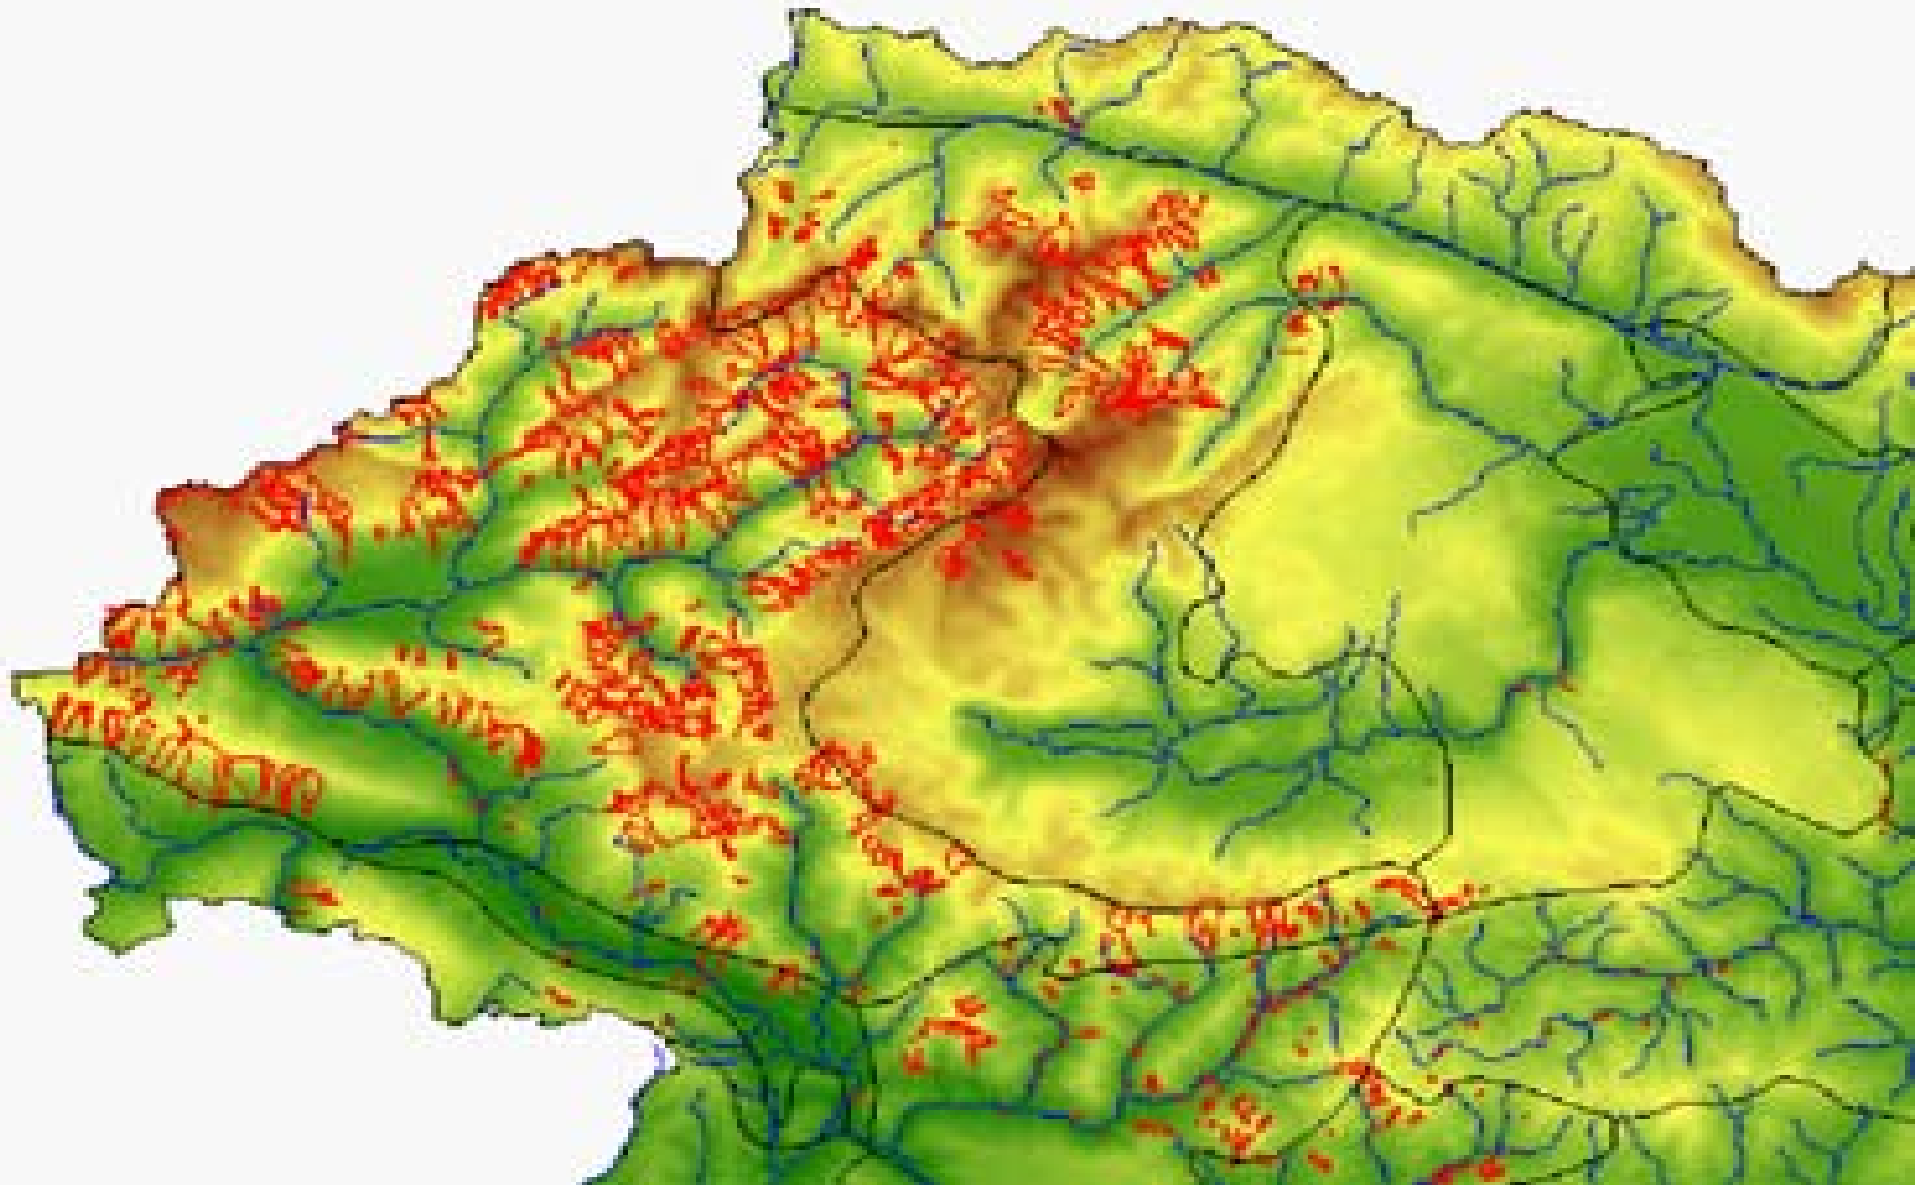
AVLANCHES IN SLOVENIA – OVERVIEW FOR NW PART

Slovenia (N=1257)
Julian Alps (N=506)

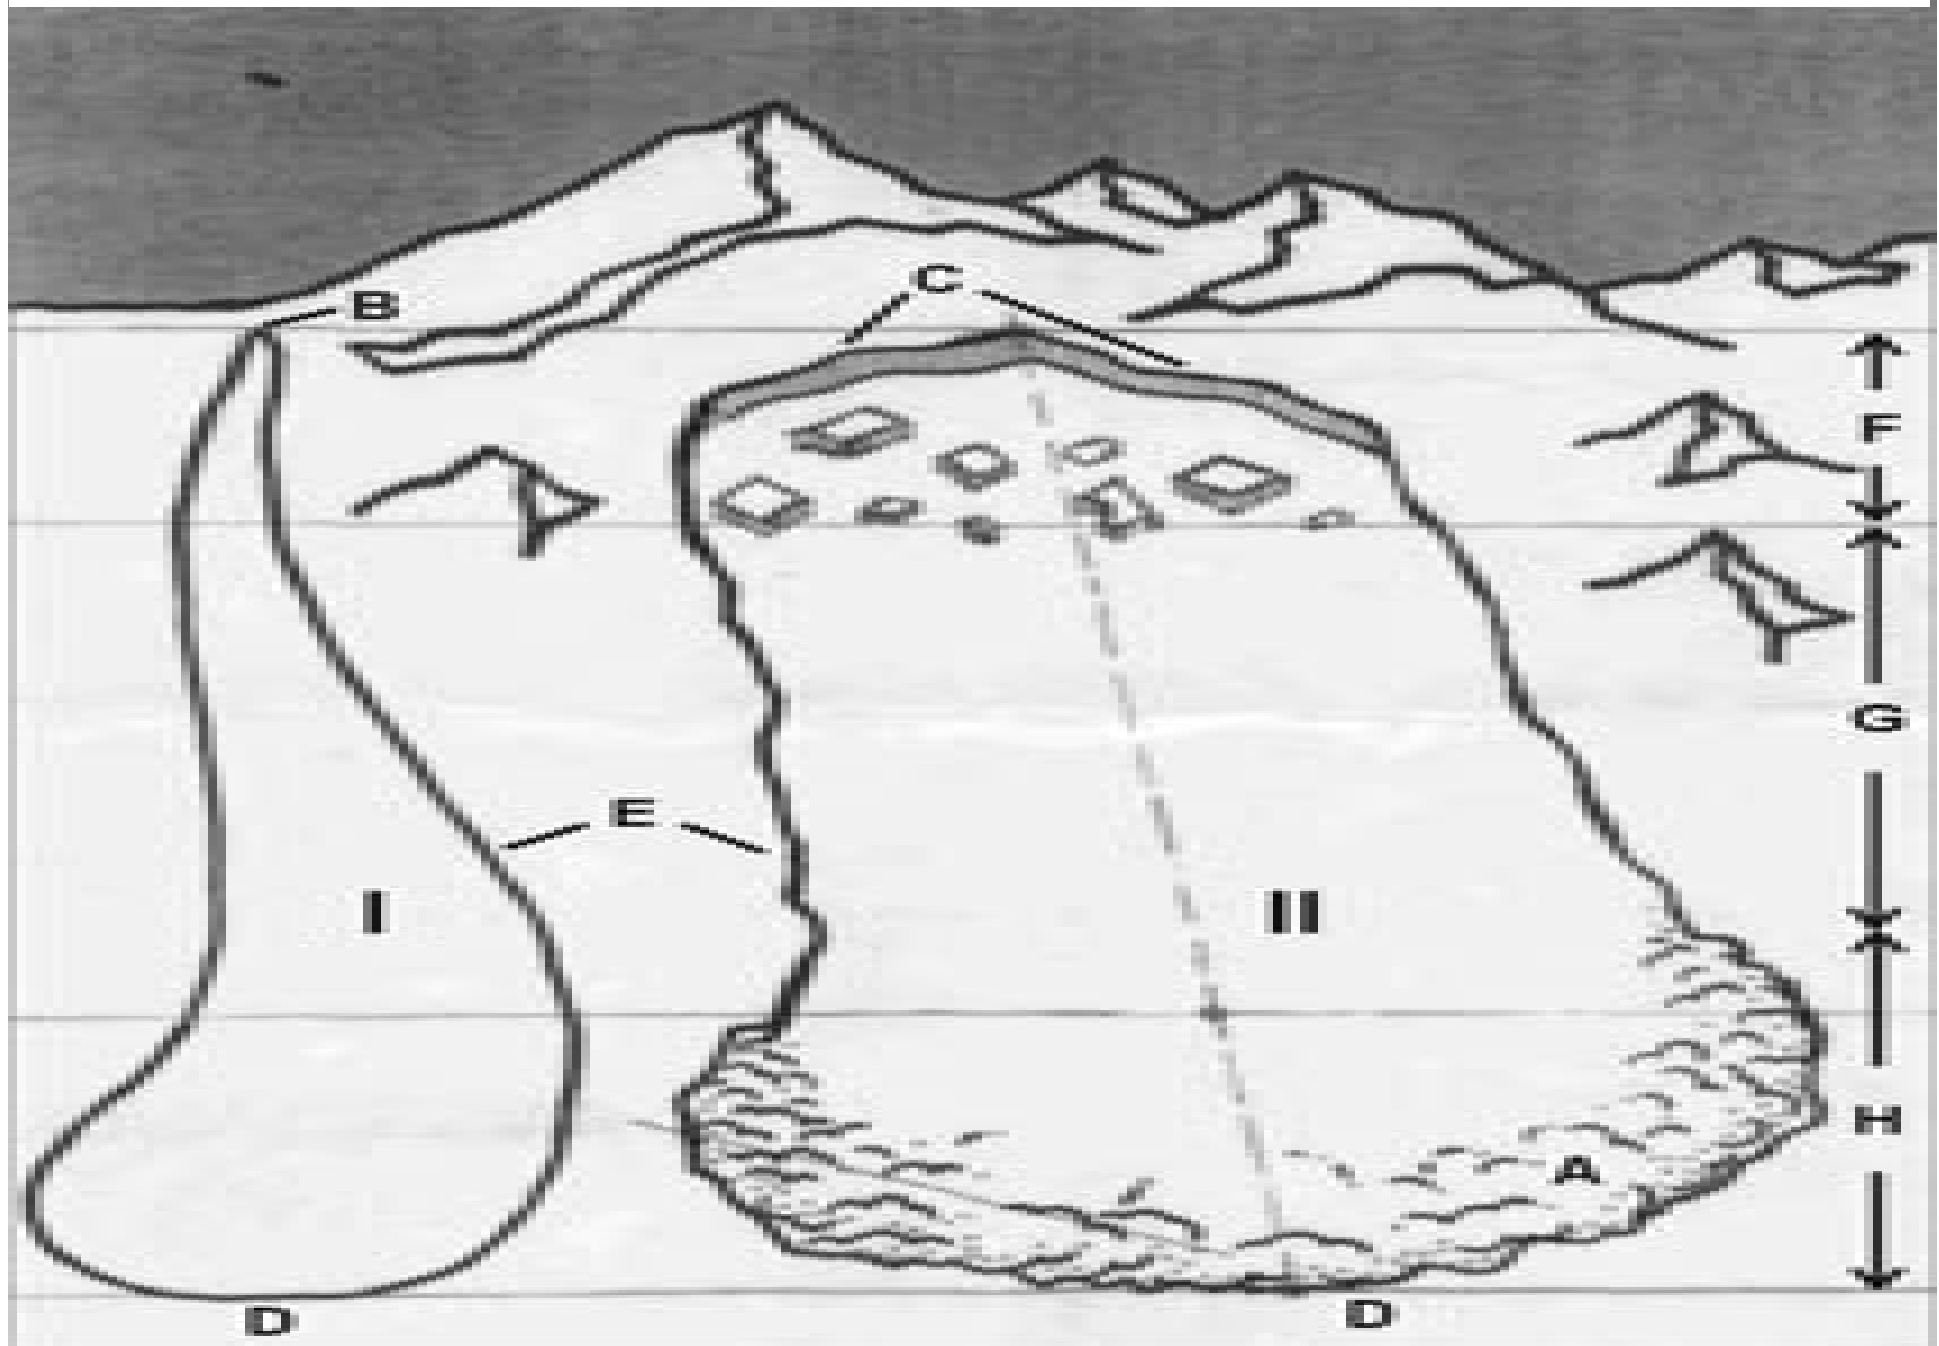
Two avalanche tracks - confined and unconfined

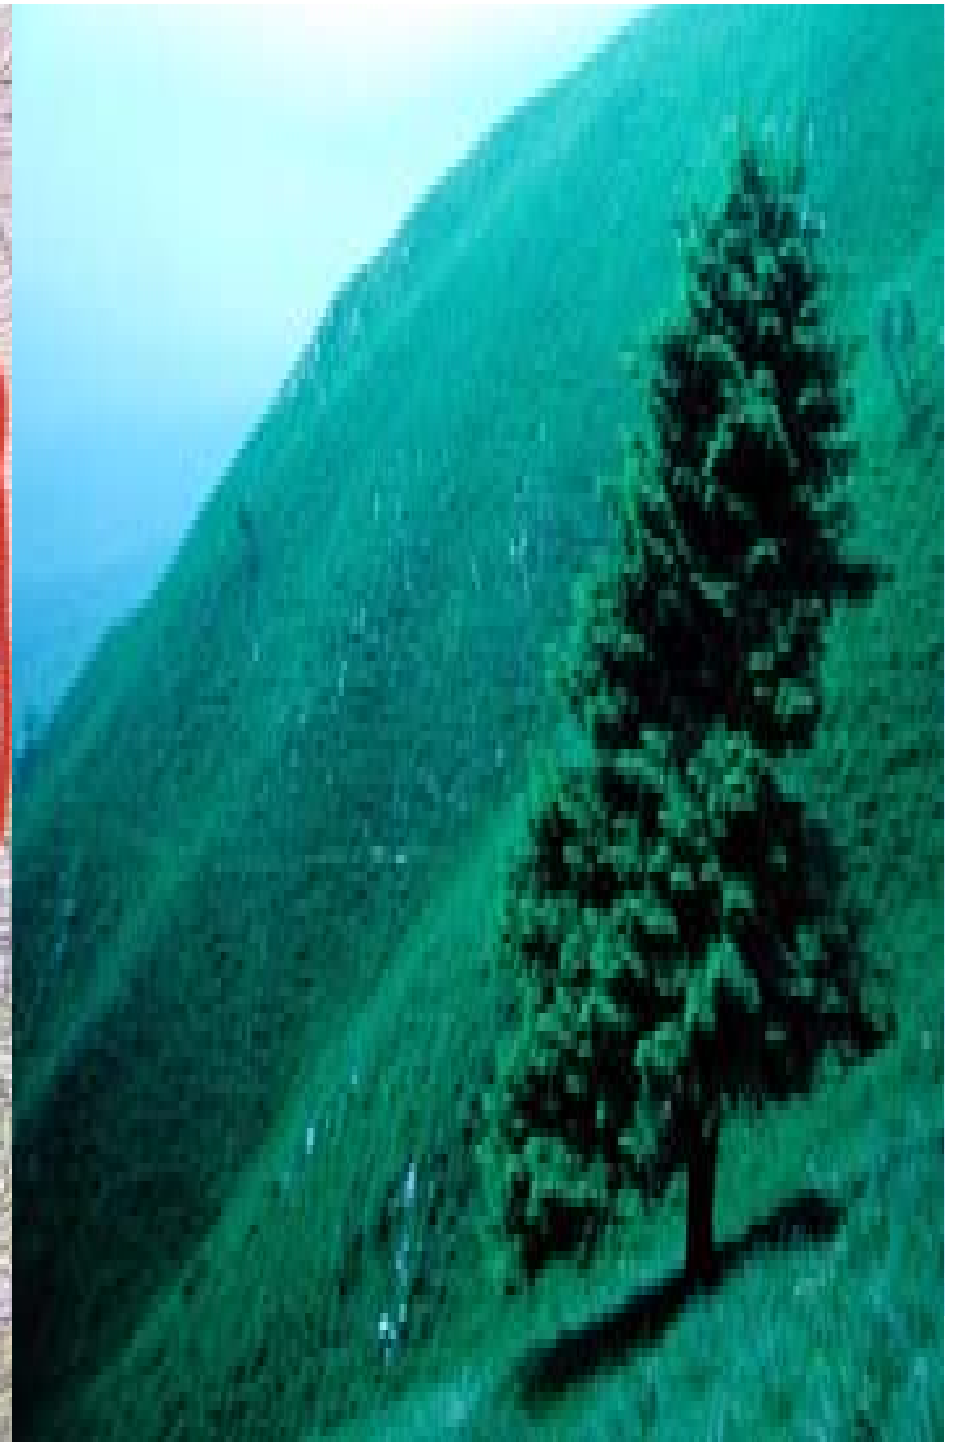
Avalanche above village Borjana
